Investigation Into the Effects of Microsecond Power Line Transients on Line-Connected Capacitors

K. Javor

EMC Compliance, Huntsville, AL

Prepared for Marshall Space Flight Center
under Contract H-29919D
and sponsored by
The Space Environments and Effects Program
managed at the Marshall Space Flight Center

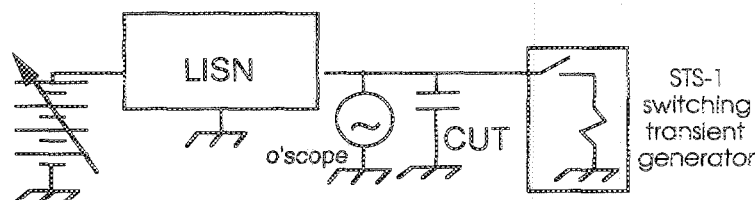
Figure 1: Schematic of switching transient test

Capacitor value is measured prior to test start, and again at end of spike application. The test is diagrammed in Figure 1. In Figure 1, CUT refers to capacitor-under-test.

The oscilloscope measures potential from line-to-ground at the LISN output. The nominal spike potential is measured without the capacitor in place, using a 1 or 10 M Ω oscilloscope probe. The spike is measured again with the capacitor in place. Spikes are imposed at a rate of at least 1 pps. Pictures of test set ups and capacitors are shown in Appendix A.

The picture above is schematically depicted below (Figure 1 from section 3.2.1):

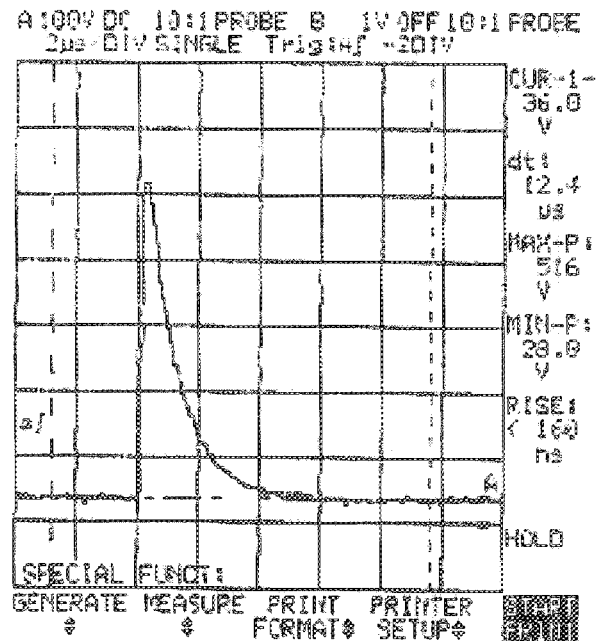
Data 1-1: 500 V spike injected on 28 Vdc

In each case (for each capacitor at each bus potential), the initial spike potential applied was 100 Volts open circuit. The spike potential actually applied to the capacitor was much decreased in amplitude from the 100 Volts measured open circuit. This spike potential was applied for several minutes. The capacitor value was measured, found to be unchanged, and the spike potential increased to 200 Volts. The same process was reiterated until the maximum 500 Volt spike was applied. At this point, spikes were imposed at a rate of at least 1 pps for over one hour. At least 3600 spikes are thus applied at the maximum potential to which the capacitors are exposed and to which they are considered qualified. After this final application, the capacitance is again measured (and found to be unchanged in all cases). Test data is shown below for the final 500 Volt spike application for each type of capacitor and bus.

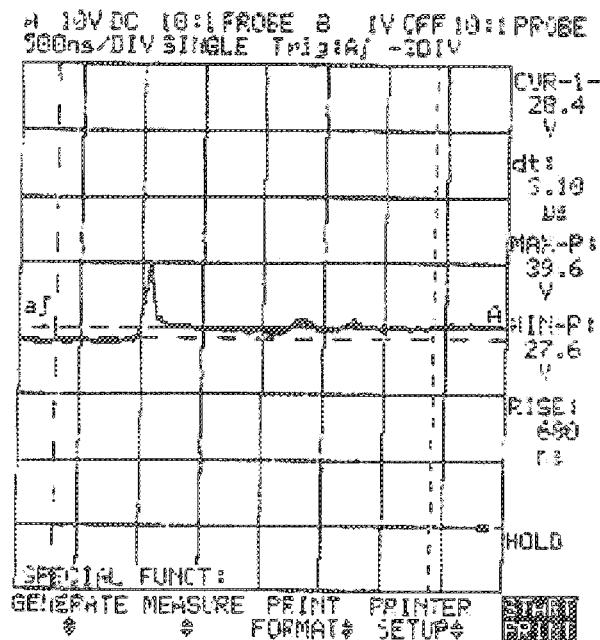
Data 1-3: Spike of Data 1-1 on capacitor E

In order to show just how benign the switching transient is, the same 500 Volt spike as of Data 1-1 was generated across a 300 μ F tantalum electrolytic rated at 30 Vdc (Cap E), while it was biased at 28 Vdc. The resulting spike is presented in Data 1-3. It is almost identical to the spike of Data 1-2, except here the peak spike amplitude (spike plus nominal dc potential) exceeds the capacitor dc rating. Nevertheless, a three hour exposure at one pulse per second resulted in no observable change in capacitance, and no observed heating.

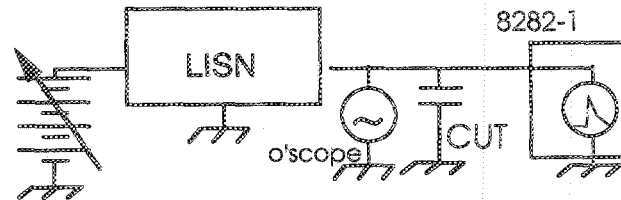
Figure 2: Test set up of CS06-like parallel spike injection

An unloaded source potential of about 700 Volts may also be deduced from this data. The test set up was identical to CS06 parallel injection with two differences. A MIL-STD-462D LISN was used in lieu of the MIL-STD-462 suggested 20 μH coil, and the EUT (capacitor) was connected directly to the Model 8282-1 parallel output banana jacks. Lead lengths were thus minimized. Pictures of test set up may be viewed in Appendix A.

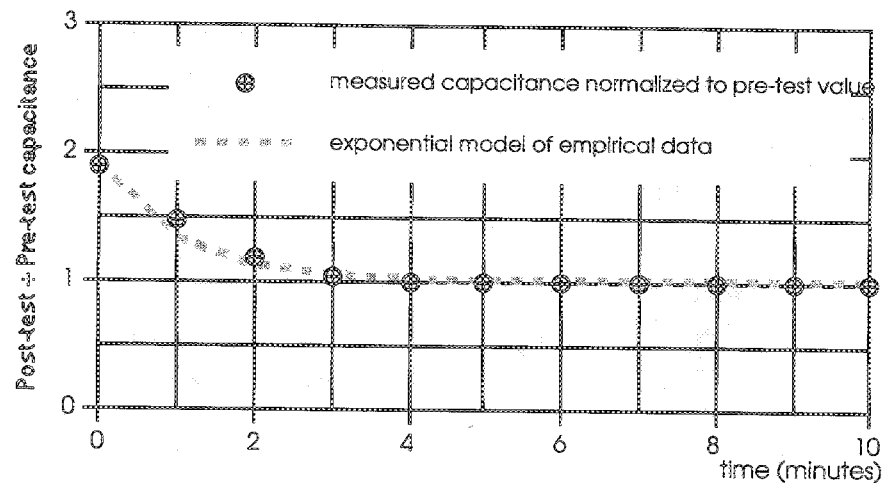
Figure 3: Capacitance as a function of post-test time

Strong correlation between capacitance and predicted temperature as a function of time indicates a very high probability of a causal relationship between electrolyte temperature and capacitance.

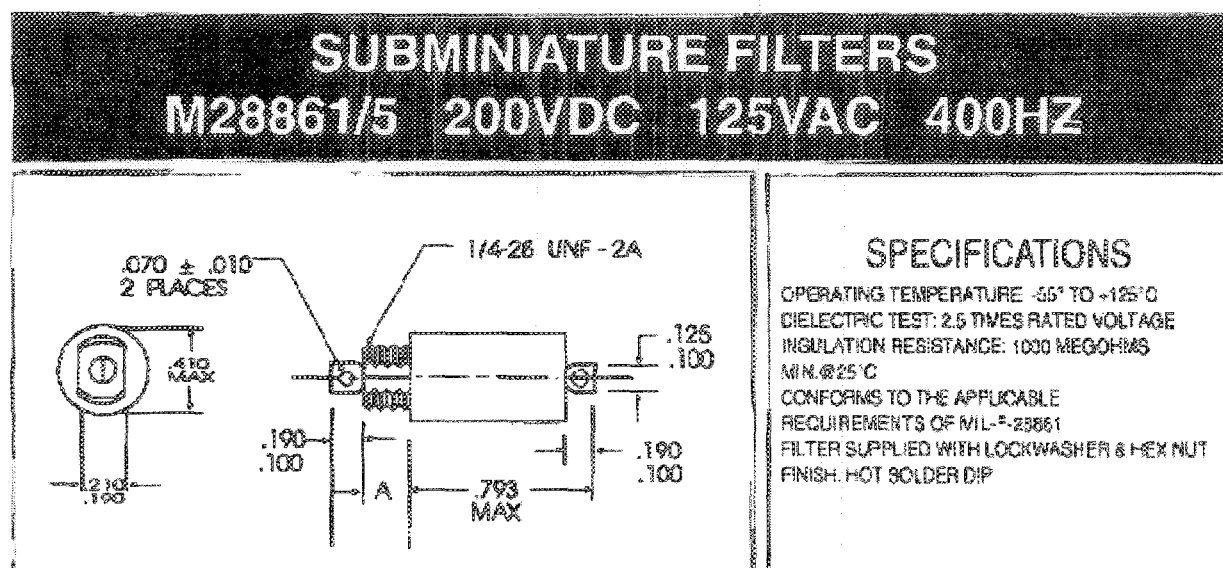
Filter F was an L-filter rather than a discrete capacitor. Line-to-ground cap value is 0.2 μF , other specifications, taken from the RFI™ catalog, are given below.

M28861/5 DASH#	RFI PART#	CKT	AMP	RATING DCV	ACV	A ₂ DB	MAX V DROP	MINIMUM INSERTION LOSS IN DB	100KHZ	150KHZ	200KHZ	100KHZ	100KHZ	100KHZ
0001	RF6905-1	L ₁	25	200	125	.187	.375	22	28	40	60	60	70	
0002	RF6905-2	L ₂	25	200	125	.187	.375	22	28	40	60	60	70

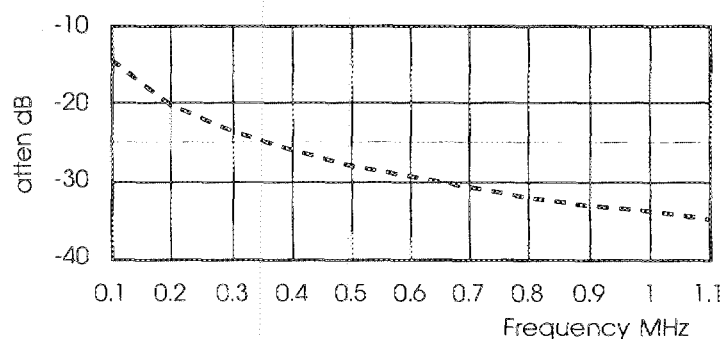
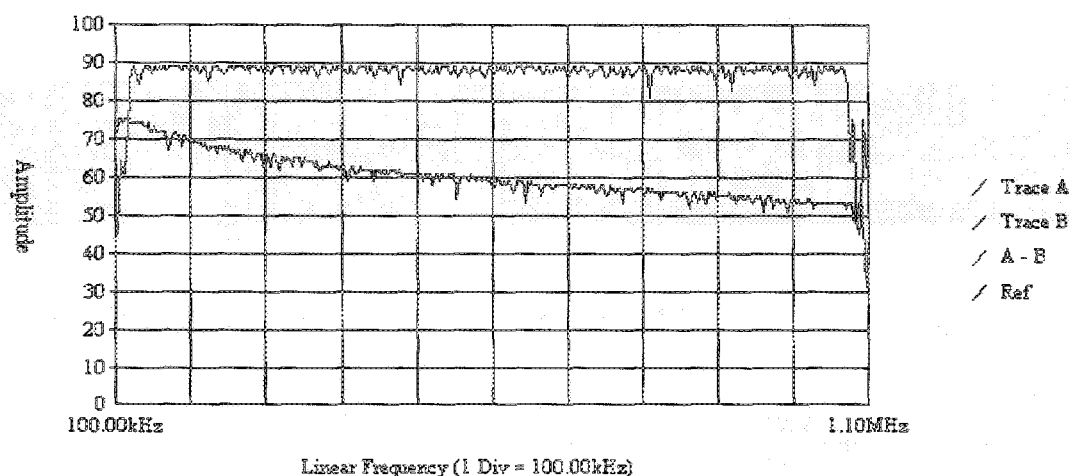
No manufacturer specifies filter series inductance, so this had to be measured. A series insertion loss technique was used. The filter was placed in series between a 50 Ω signal source and a 50 Ω spectrum analyzer. No connection whatsoever was made to the filter case, so the capacitor had no effect on the measurement. A baseline measurement was made without the filter in line, so that insertion loss could be ascertained. The equation which predicts the insertion loss is:

Test set-up schematic and equation is plotted below for $L = 400 \mu\text{H}$, over a 100 to 1100 kHz range. Test data shows excellent agreement with theoretical insertion loss for 400 μH . Test data upper trace A is a baseline measurement without the filter in the test circuit. The lower trace B is due to the insertion of the inductor in series between signal source and receiver.

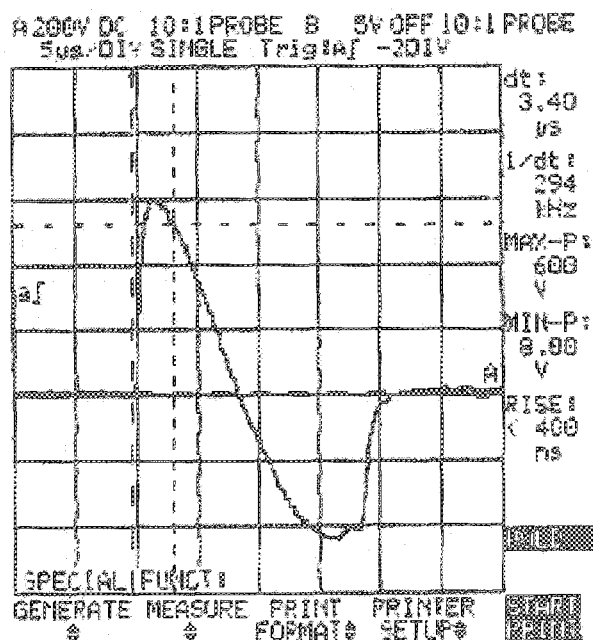
Data 2-1: 600 V spike across 5 Ω

The 600 V, 10 μs spike of Data 2-1 was injected on to capacitors B through E, with no test failures. All tantalum electrolytics got very hot during this test. These tests were run for at least one hour at one pulse per second. The ceramics were run at 2 pps with no noticeable heating. One tantalum electrolytic, capacitor E, read 386 μF immediately at test end (very hot), but 316 μF after returning to ambient temperature. This was not deemed a failure.

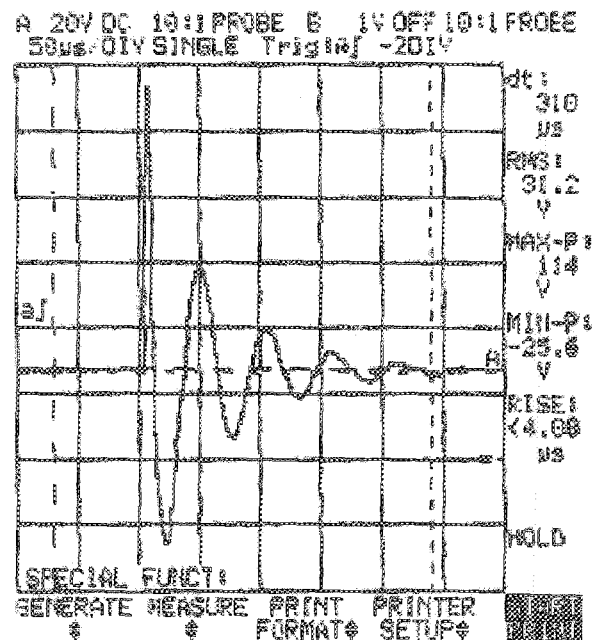
Data 2-3: Data 2-1 generator setting develops this spike across capacitor E

The most important result here is Data 2-3. This is the induced spike across the 300 μF , 30 Vdc rated capacitor (E) biased at 28 Vdc. With absolutely no headroom to spare, this capacitor still did not fail when the 600 Volt spike was injected. Note that about 600 Amps was flowing at the peak of the spike waveform in order to result in an applied spike amplitude of 114 Volts (greater than 700 Volts source potential loaded through 1 Ω source resistance down to approximately 100 V). It is quite reasonable to extrapolate from this result that no properly derated tantalum electrolytic bulk capacitor will be damaged by any low duty cycle CS06 - like spike application.

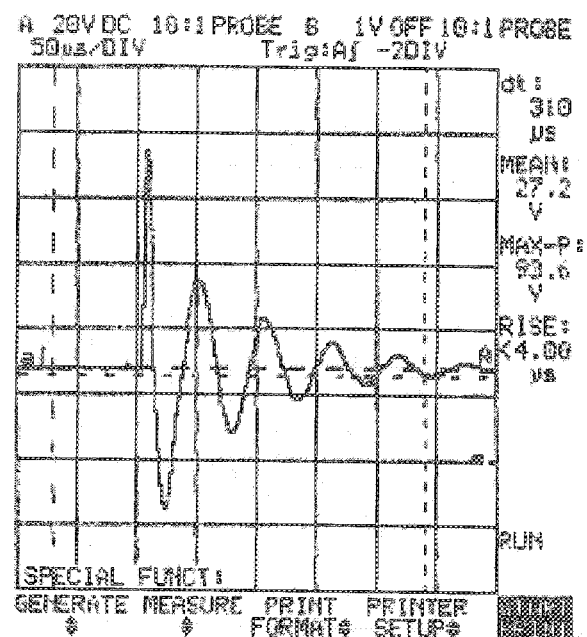
Data 2-8: Maximum generator setting develops this spike across capacitor E at 10 pps

Having completed a one hour application of a 10 pps 600 V, 10 μ s spike to a 60 Vdc rated capacitor (A), an identical test was performed on a 30 Vdc rated capacitor (E). Data 2-8 shows the spike applied to capacitor E (recall that Model 8282-1 amplitude is at maximum, yielding over 600 Volts peak into 5 Ω). Both capacitors A and E were biased at 28 Vdc for these tests. Capacitor E gave similar results to A post test, but hot capacitance exceeded the capacitance meter's range and could not be measured until it was nearly room temperature. Post-test, the clear plastic coating of both capacitors was discolored by the extreme heating. It is possible that if the case of such a capacitor were in contact with a printed circuit board (PCB), that damage to the board could result. However, recall that the applied spike in the above cases was 600 Volts peak. No CS06-like specification calls out such a spike at such repetition rates for an hour.

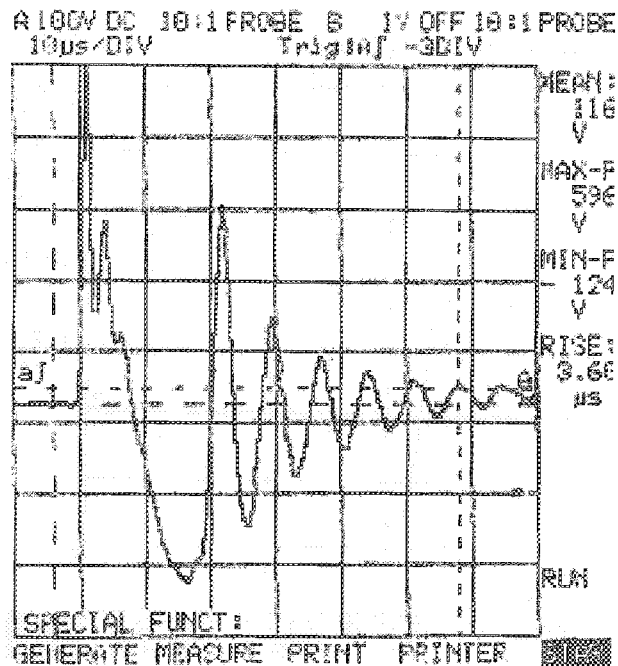
Data 2-15: Filter F response to Data 2-14 spike injected into capacitor side

Filter F provides the best example of how correctly defining a switching transient provides design relief. Data 1-7 is filter F response to a 50 Ω spike of total (spike plus line potential) 540 Volts (Data 1-4). The applied spike measured 420 Volts (540 - 120 V) open circuit, and would have measured 210 Volts into 50 Ω . Spike amplitude in Data 1-7 is only 116 Volts (236 V - 120 V). Filter capacitor succeeds in loading the transient potential sufficiently that no damage is done. Contrast this filter efficiency with what happens when a Model 8282-1 spike is applied to the same filter F, as shown in Figure 3. Data 2-14 shows a 240 spike (from SSP 30237 CS06) developed across 5 Ω . Data 2-15 shows the same spike applied to the capacitor side of filter F.

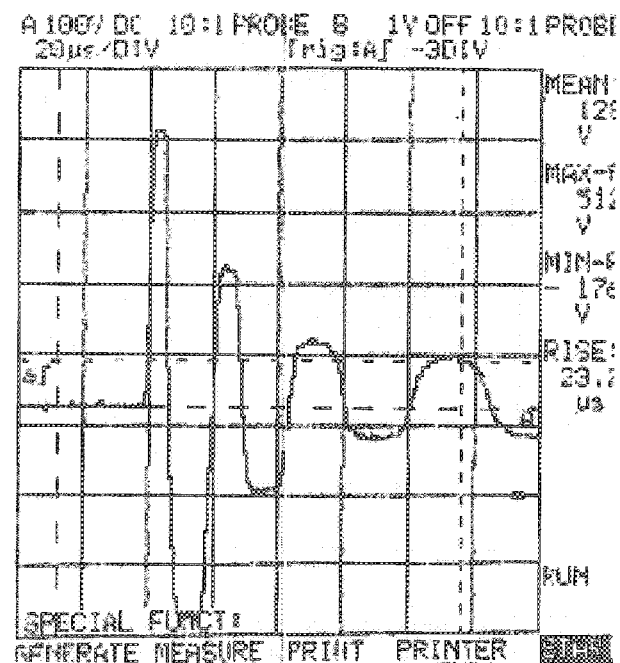
Data 2-16: Filter F response to Data 2-14 spike injected into inductor side (measured across capacitor)

The peak potential has increased from that shown in Data 2-14 because the capacitor is a higher impedance than 5 Ω . If the filter is turned around so that the inductor bears the brunt of the spike, the potential across the capacitor is shown in Data 2-16. Spike potential is reduced from that measured when injected directly into the capacitor, but it still exceeds the potential the Model 8282-1 can deliver into 5 Ω . The inductor is incapable of significantly filtering the spike.

The table below shows the response of the filter to CS06-like spikes. Filter F failed from a single 5 or 10 μ s at about 450 V spike applied to the inductor end, when biased at 120 Vdc. It could take the SSP 30237 10 μ s 240 Volt pike at 10 pps indefinitely. It failed within two minutes of 350 V 10 μ s spike 10 pps applications on the capacitor end. When spike duration was reduced from 10 μ s to 5 μ s, damage threshold at 10 pps injection increased from 350 to 420 Volts (it took 2 minutes to fail at the same rep rate at 420 Volts).

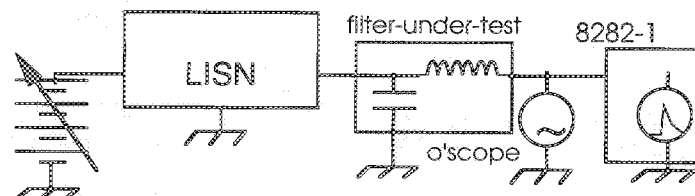
Figure 3: Test set up of CS06-like parallel spike injection for single filter F. (Either cap side or inductor side face the spike source.)

However, the test set-up of Figure 3 harkens back to the days when a MIL-F-15733 type filter was installed in just such a line-to-ground configuration because power current was returned

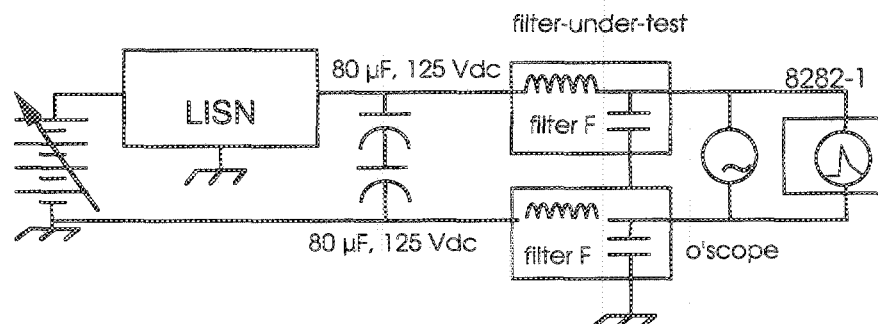
Figure 4: Test set up of CS06-like parallel spike injection for two filters F in modern power bus topology.

through metallic platform structure. Nowadays it is much more common to return current on a dedicated wire, at least until return current exits the equipment enclosure. The test set-up of Figure 4 is a better model of modern power bus and filter topology.

In Figure 4, the filters F are paralleled by $40 \mu\text{F}$ of bulk capacitance. This should help to lower the spike potential across capacitors in filter F, but filter F inductors interfere with that function. Data 2-17 shows a 450 Volt spike calibrated across 5Ω . This is the potential at which a single application destroyed a stand-alone filter F. Data 2-18 shows the spike potential when the setting resulting in Data 2-17 is applied as in Figure 4. For comparison, Data 2-19 shows spike potential between filters F and the bulk capacitors. Almost the entire spike potential is dropped across filters F. However in this test configuration the 450 Volt spike did not affect the filters F, even applied at a rate of 10 pps for several minutes. When the spike potential was increased to 500 Volts (at a rate of 10 pps) it caused filter F capacitor failure in less than one minute.

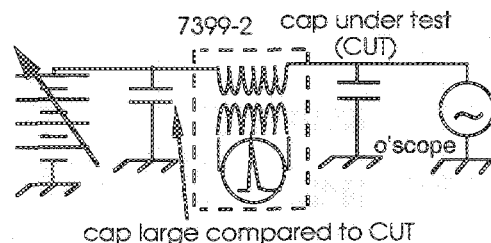
Figure 5: Test set up of CS06-like series spike injection

An unloaded source potential of about 2000 Volts may also be deduced from this data. The test set up was identical to CS06 series injection with only the 7399-2 replacing the Model 8282-1. The capacitor under test was placed in an explosion chamber in case it failed catastrophically. Pictures of test set up may be viewed in Appendix A.

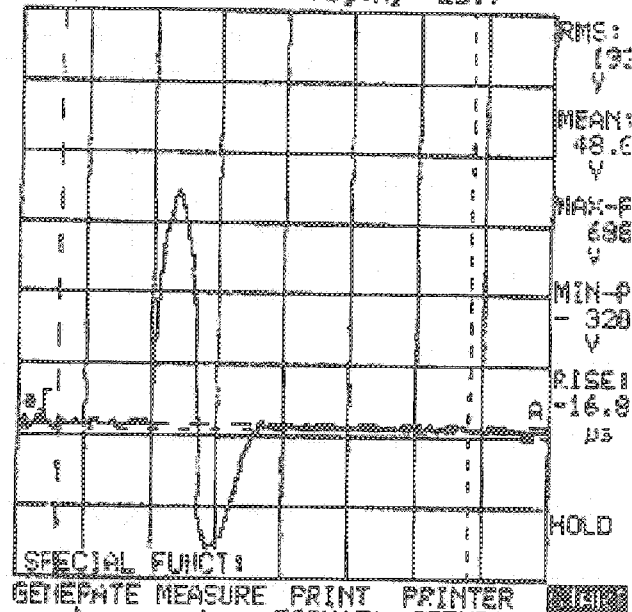
Data 3-5: Data 3-1 generator setting develops this spike across capacitor E, which caused eventual failure

Capacitor E failed at a Solar Model 7399-2 spike source applied potential of 600 Volts for 20 μ s. Amplitude was 1.32 kV into a 0.5 Ω resistor. The spike source impedance was 0.25 Ω . It took almost four hours to fail the capacitor, with spikes applied at a rate of two pulses per minute.

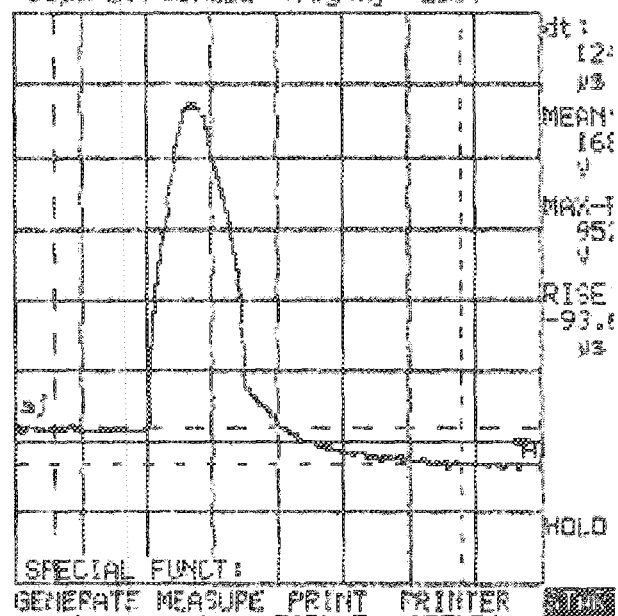
Data 3-15: Data 3-14 generator setting develops this spike across capacitor A.*

* Note that whereas at lower potentials the capacitor A spike potential was roughly half of the potential applied to 0.5 Ω , here the capacitor potential has risen to about 70% of the 0.5 Ω potential. This was indicative of the onset of capacitor failure. After application of this spike, the pre-test nominal capacitance of 140 μ F was reduced to 1 μ F.

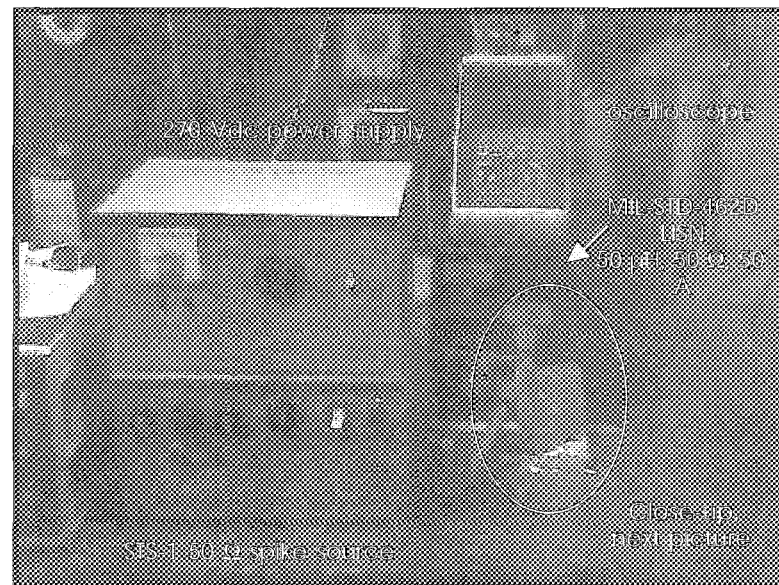
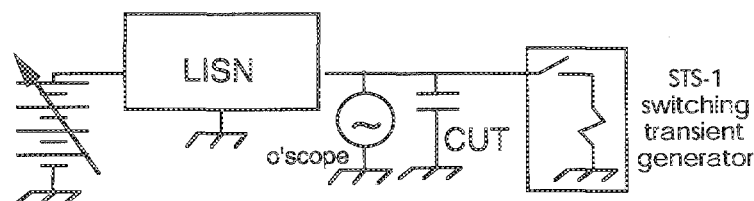
Picture 1: 50 Ω spike source test set up. Capacitor is connected to LISN power output and brass bond strap to minimize potential drop across capacitor leads and connections. The power supply hot output is connected to the back side (power input side) of LISN. A large capacitor also bypasses the LISN power input to ground, to provide local energy storage. Switched current is high in magnitude relative to what the power supply can deliver (also there is inductance/resistance in leads between the supply and LISN). The electrolytic capacitor (on the order of mF) has its high side connected to the LISN power input connector using a solder wick bond strap less than one inch long, and a sheet of thin brass stock from the low side of the capacitor to the ground plane, providing less than 3:1 length-to-width ratio in the ground path.

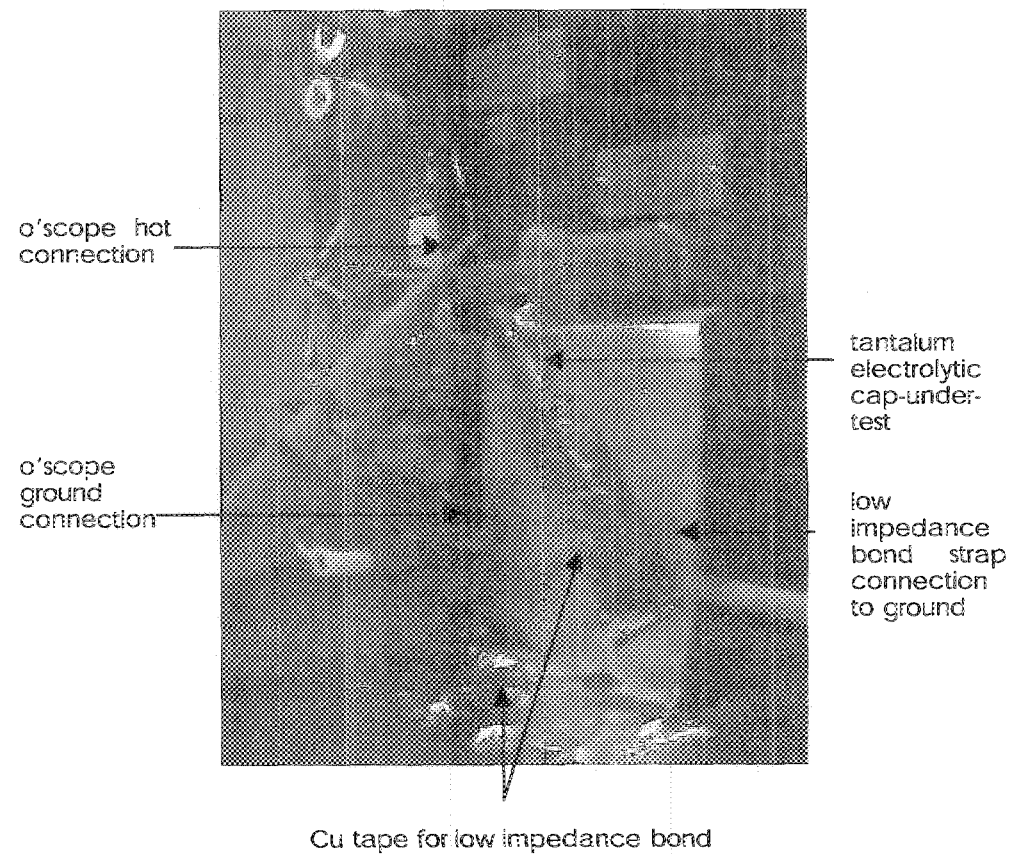
Picture 2: Close up of tantalum capacitor connection to LISN output in 50 Ω spike test set up. Capacitor lead length has been minimized by close connection to LISN port and use of brass bond strap extension of ground plane.

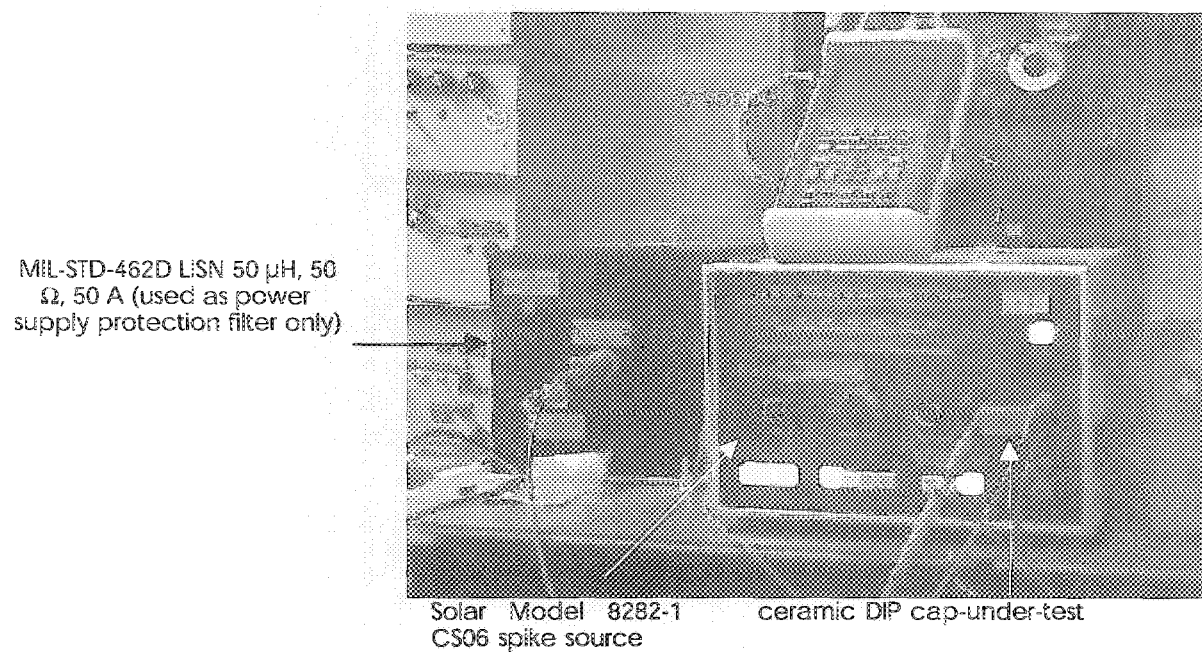
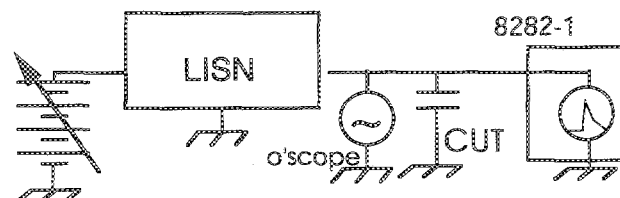
Picture 3: CS06 parallel injection test set up. The LISN here is a filter protecting the power supply output from the CS06 spike. Note that capacitor under test is connected directly to Model 8282-1 parallel output jacks to minimize lead impedance. Figure 2 (from section 3.2.2) below is a schematic of above test set up:

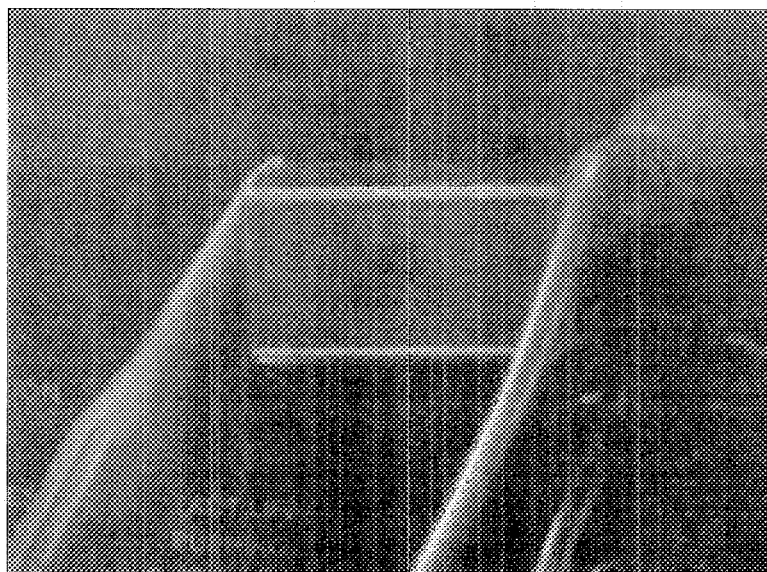
Picture 4: Close up of ceramic capacitor under CS06 spike parallel injection. Minimized lead length is apparent. Note that ceramic capacitor is configured as a DIP, but all leads on one side are common. These were interwoven with solder wick and EMI tape to provide very short, low impedance leads for connection to either LISN terminal and brass bond strap (50 Ω spike test) or Model 8282-1 parallel output jacks.

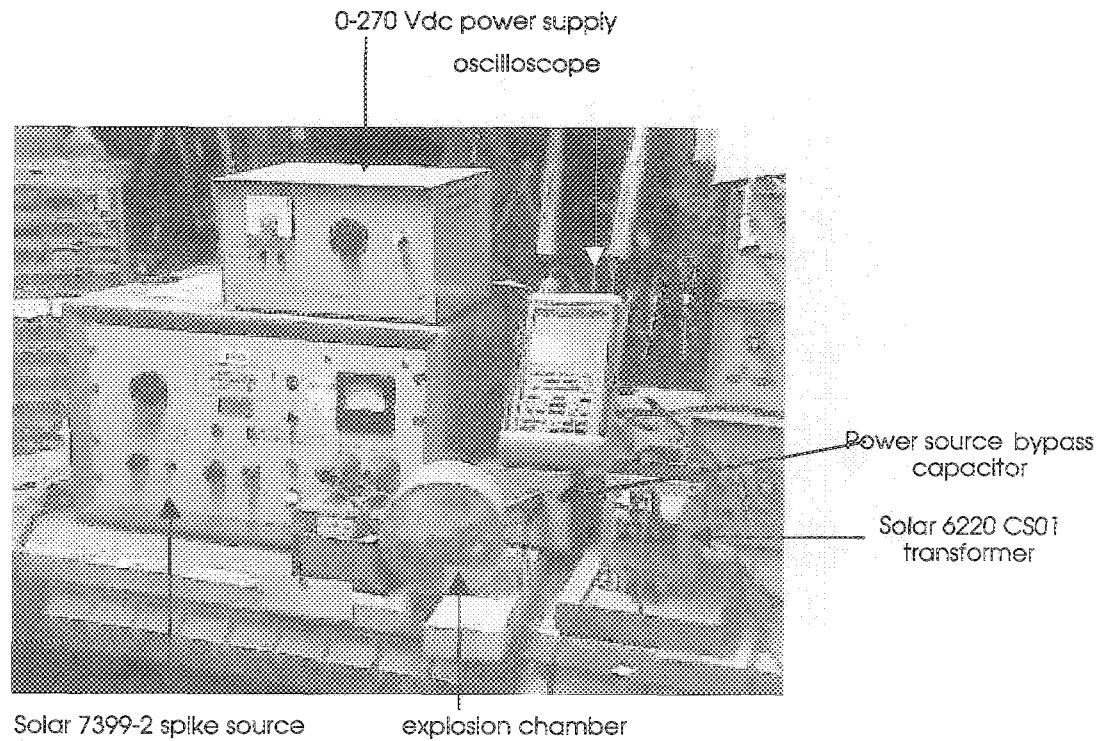
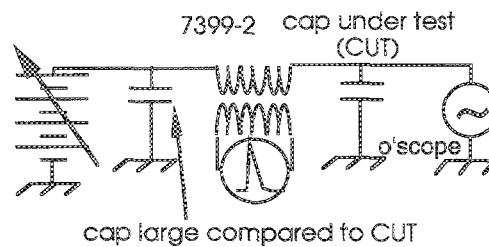
Picture 5: MIL-STD-1399 series injection test set up. Explosion chamber holds capacitor under test. Solar transformer is extra protection for power supply, recommended by Solar 7399-2 instruction manual. For clarity, it is not shown in schematic below (Figure 5 of section 3.2.3):

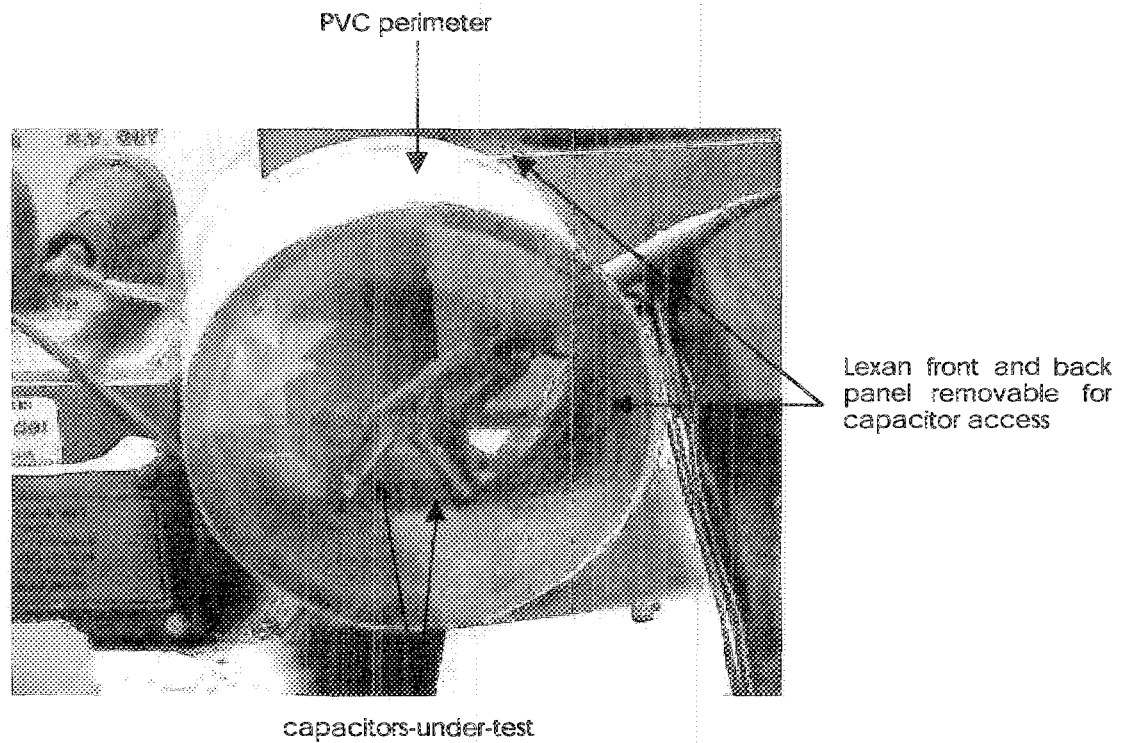
Picture 6: Close up of explosion chamber with capacitor B (two series 125 Vdc rated capacitors ganged for Space Station power bus derating) installed.

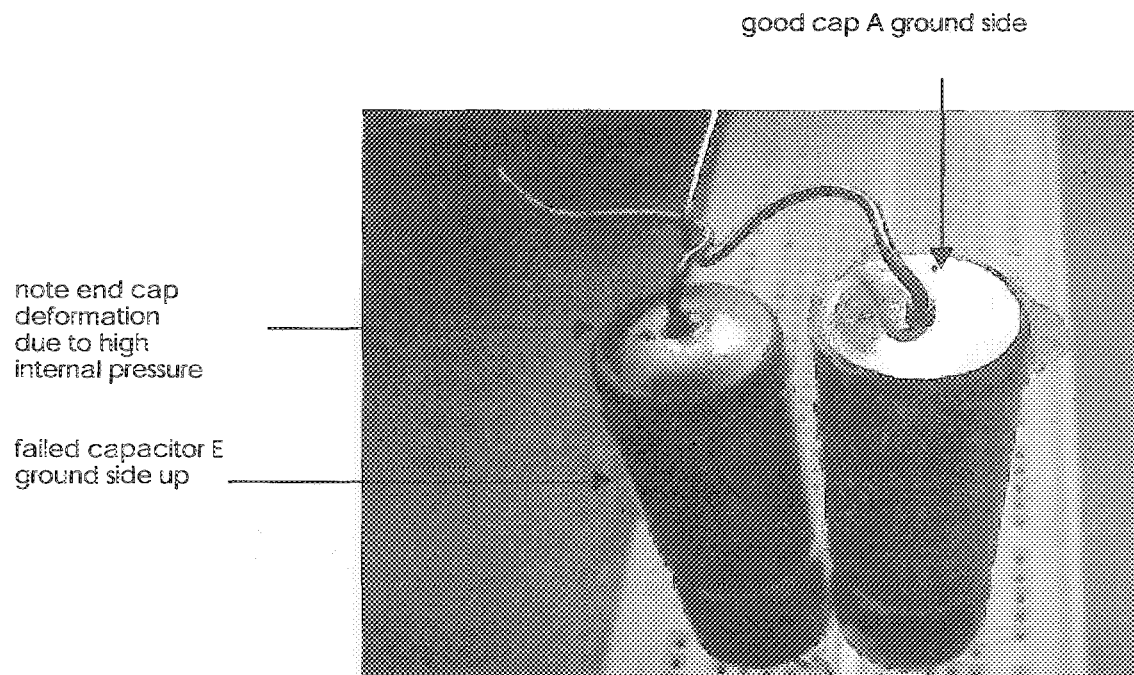
Picture 7: End view comparison of failed capacitor E with good capacitor A (same package). Capacitor E is seen to have undergone explosive compression, which, however, was contained by its case. Capacitor failed open; its failure would not have directly caused other circuit malfunction, except by its failure to perform its original function.

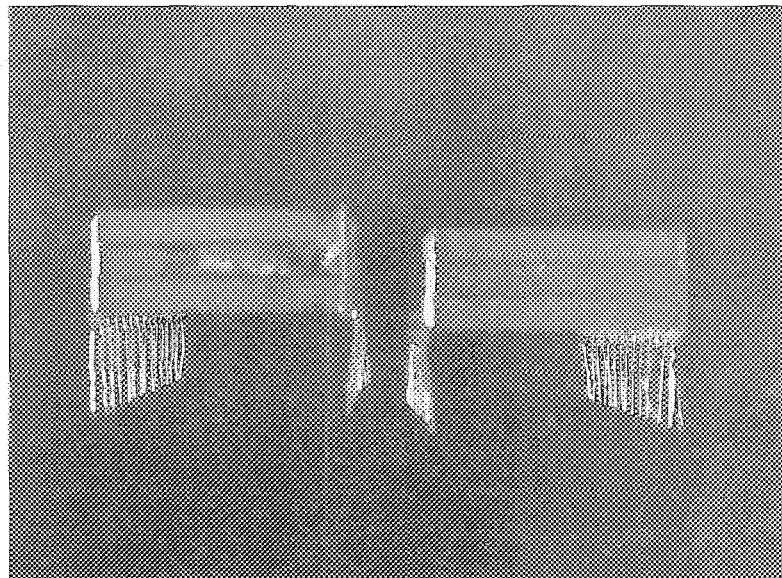
Picture 8: End view comparison of failed ceramic DIP capacitor C with good capacitor. Capacitor C dielectric has broken into pieces. Capacitor failed short, blowing a 1 Amp fuse in the power supply.

A single application of the same spike destroyed capacitor C while biased at 120 Vdc. A picture and description of the damage is shown in Appendix A. Single applications of the 63 μs spike were applied with successively greater amplitudes to capacitor A. Starting at 500 Volts (as calibrated into a 0.5 Ω load) superimposed on 28 Vdc, with 100 Volt increments up to 1 kV, and 200 Volt steps thereafter, it was determined that the single application threshold of damage occurred at 1400 Volts. At this potential, the post-test capacitance decreased to 1 μF or less (nominal was 140 μF , pre-test). In case the step-by-step incremental testing had weakened the capacitor, a fresh capacitor A was also subjected to 1400 Volts, and also failed. Test data 3-6 through 3-15 show samples of calibrated and applied spikes.
